## UNA VISIÓN DE LA METODOLOGÍA DEL DISEÑO ARQUITECTÓNICO EN EL PATRIMONIO

Juan Francisco Cazorla Arteaga  
Universidad del Azuay  
Ecuador  
jfcazorla@uazuay.edu.ec

### A Vision on Methodology in Design with Heritage

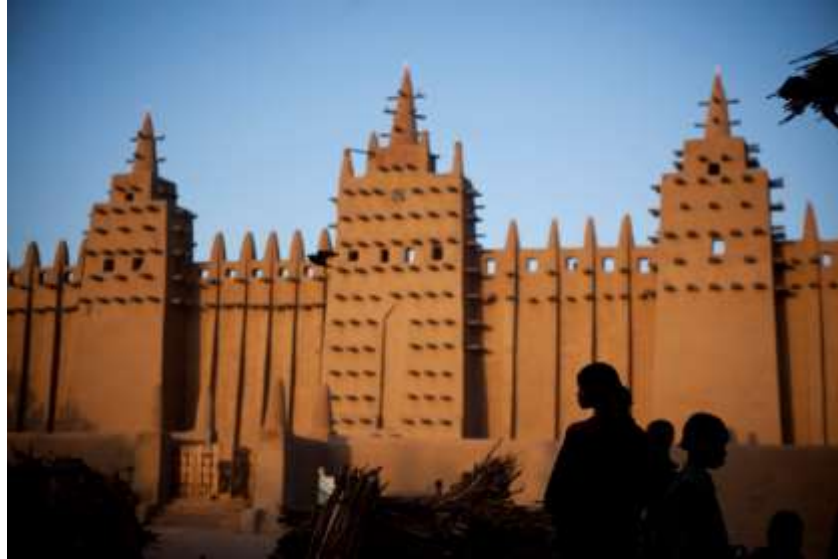
Figure 2: Dejenne City

There are several monuments which real value do not lies on standard features and require an extensive analysis to determine it. One example of this is the Dejenne city located in Mali (Fig. 2). The monument main feature is that it was constructed with mud and as a result, yearly it is partially dissolved after the rain season. The community repairs and restore the building every year as part of a millenary religious festival. This feature leads to a monument that does not have a fixed form, since yearly it is repaired, yearly it changes its shape. As a matter of fact, the real value of Dejenne city is not the form of the building, it is the damage process of its material that leads to the repairing tradition (Paul Meurs, 2014). As a result, the architecture of the monument evolves with time, which is the essence of the building. A lack of understanding of this feature, or applying standardize charters values in a restoration process can destroy the repairing tradition, the real authenticity of the monument; which is the main feature that a restorer should look to preserve.

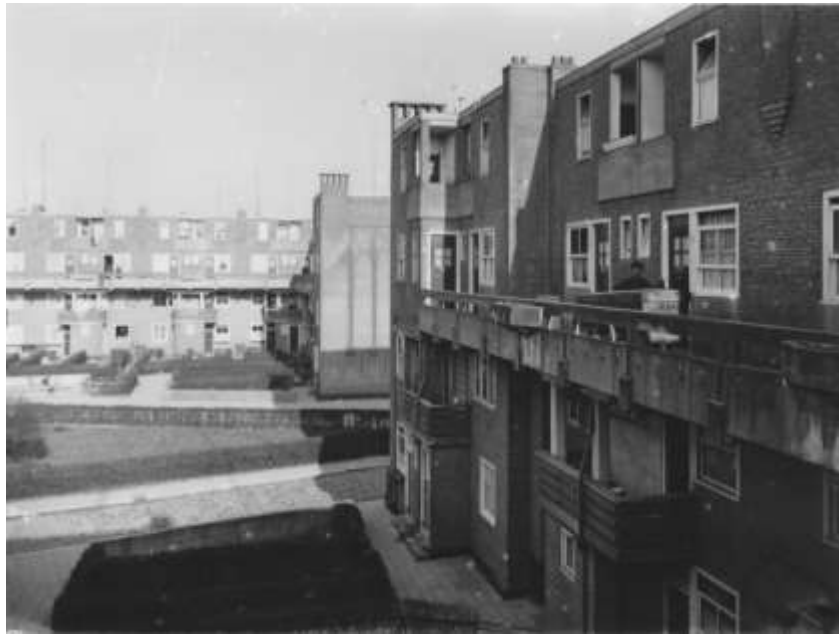
Figure 3: The Justus van Effen Residential Complex 1920

The understanding of a building is transcendental to achieve a successful intervention. The Justus van Effen residential complex located in Rotterdam Spangen in The Netherlands was design by Michael Brinkman and built on 1920s. (Fig. 3) The project design was focused on the ‘street life’. The plot distributed standardized departments units around a big gallery that emulates the street on the higher level of the complex. Additionally the project was designed around a central patio with share showers facilities on its core. These share spaces enhanced the social interactions between neighbours and created a community in the original housing project.

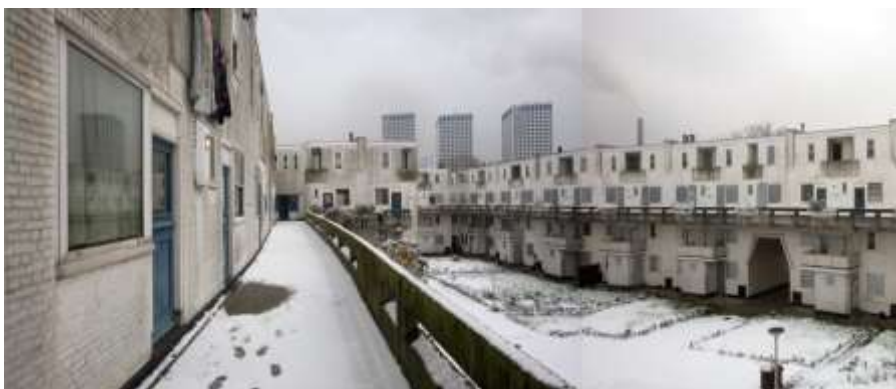
Figure 4: The Justus van Effen Residential Complex 2010 before Intervention

Due to the modern life requirements, the project experimented a major renovation on the 80s (Fig.4). The apartments became bigger; the complex went from the 264 original units to 164. Insulation as well as new finishes were incorporated in the building. Additionally each department was upgraded with private shower facilities. Finally the appearance changed; the building complex went from being characterized from its brick texture to a white neutral painting. Even when the functional features of the building were upgraded the intervention was totally unsuccessful, because the renovation did not understand the building. The intervention destroyed the social interaction between the residents and the identity of the complex. As a result, with the functional upgrades, the project went from being a successful high-dense residential project into a slum (Molenaar, 2014).

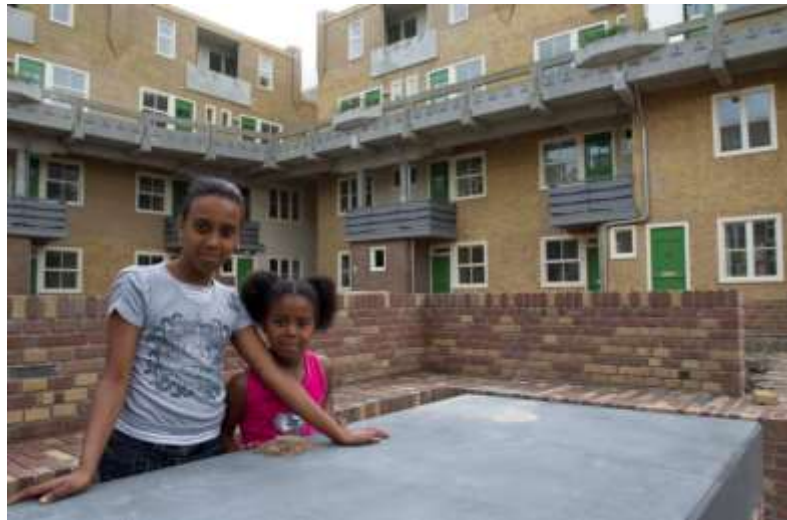
Figure 5: The Justus van Effen Residential Complex after 2010 intervention.

A new intervention took place on 2010 (Fig. 5). Differently from the 80's intervention this one started with a research to understand the values of the original project, what made it successful. As a matter of fact, the re-design tried to bring the original concept back, 'the street life', by re-distributing the apartment modules and trying to generate again the community life towards the gallery. This intervention as well as the one of the 80's functionally upgraded the complex to adapt it to contemporary standards. However, the last one was successful because it understood the building and its values. Despite of that, there are still problems with the cohesion of the neighbourhood, the security and that some elements like the shared showers (nowadays communal room) facility do not have the vitality of previous years; nevertheless the project was successful (Molenaar, 2014).

Both redesigns took similar approaches. They enhanced the functional features of the project and did an aggressive intervention to the original building. Nevertheless, what made the difference between them was that rather than applying a standard solution, the late intervention understood the complex; its approach was more scientifically, it looked for rescuing the values and tried to improve the weaknesses of the project. As a result, it saved the historical soul of the complex and gave the project a present life with the restoration.

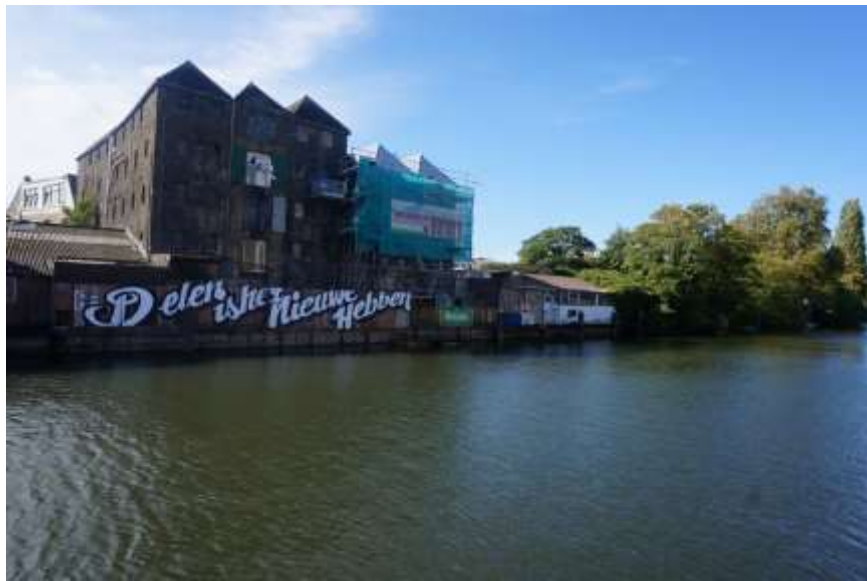
Figure 6: The Soda Fabrik 2014.

The uniqueness of a building can be discovered only when it is understood. The Soda Fabrik (Fig. 6), located in Schiedam in the Netherlands, was selected to be the focus of a renovation project at TU Delft on late 2014. This building was approached with an ABCD analysis method. After the research, the analysis concluded that the values on which the project was founded were diverse. The urban values were transcendental to define the program and the design intervention. Some of them were the connections to the city and the uniqueness of the neighbourhood, while the development plan of the city of Schiedam defined the new program (Fig 7.).

The building analysis, at an architectural level, highlighted some valuable features to preserve like: the shape, the different types of construction, the warehouse typology, the flexibility of the building and even some of the damage of the complex. Additionally, the design tried to preserve the production feature. The building used to house a soap factory of soap; therefore, the proposal wants to transform the Soda Fabrik into a factory of business ideas.

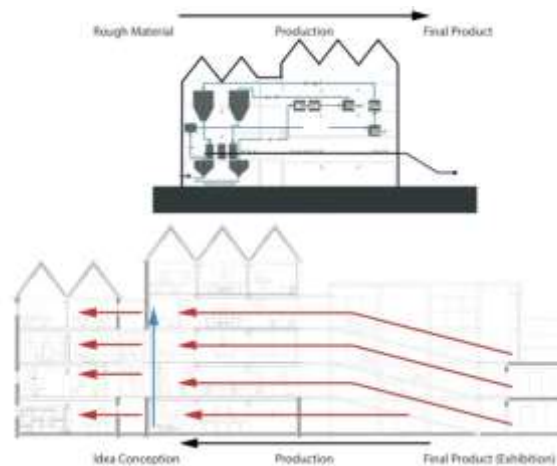
Figure 8: Soda Production / New Circulation

The intervention was designed as an adaptive reuse. It respected the main buildings and created a few openings in the southeast façade to allow new circulation, which emulates the old soda process (Fig 8) and connects the old building with the new show room. Additionally, the new design tried to merge the not integrated complex of the project, which is partly composed by residential units and partly by industrial warehouses. With

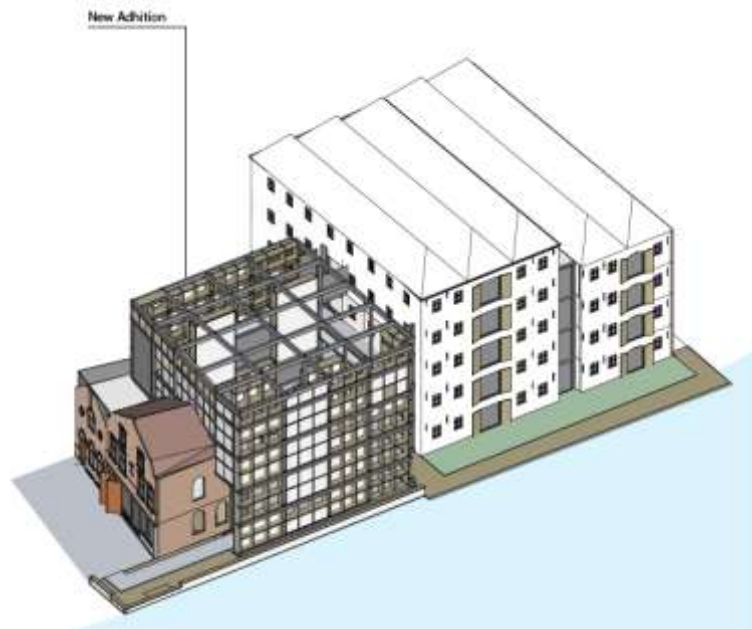
Figure 9: Soda Fabrik Intervention

this addition, the design pretends to consolidate the project with harmony in a single complex but respecting the diversity of each unit (Fig 8,9).

The design approach to the Soda Fabrik tried to preserve the unique historical values, improved what was not valuable and adapted the building to host a new function. Rather than focusing only in preserving and freezing in time an old monument the design approach tried to bring the lost life and glory of the Soda Fabrik.
